# Rigid Scopes and Associated Problems

**Knowing more about a problem may lead to its prevention.**

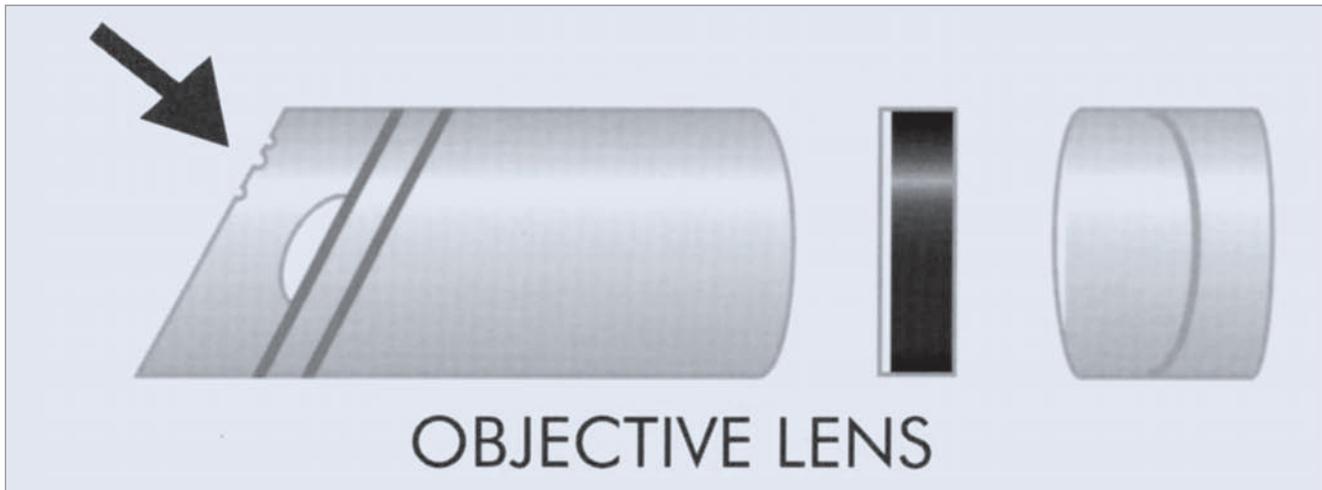
## 1. BROKEN ROD LENS

The most common repair on a rigid scope is the replacement of damaged rod lenses. Rods of flint or crown glass have replaced the previous trains of field lenses, resulting in a design which increases light transmission by minimizing air spaces. A typical rod lens is 1.0 to 6.0 mm in diameter and between 5.0 and 50.0 mm long. There are many lens configurations but a common format is to adhere a couplet on one end and a singlet on the other end of the rod. Pairs of these lenses separated by a spacer transfer the image the length of the pair, successive pairs transfer the image the length of the scope where it is magnified by the ocular and viewed.

The great advantage of the rod lens over a fiber image is the increase in resolution, making it ideal for surgery. The disadvantage is the rod lens is prone to breakage, occurring from impact or flexing of the tube. A broken rod lens may appear as a darkening or clouding of the image, as if looking through broken glass, or by having no image at all. To reduce breakage, certain model scopes are spring loaded to absorb shock and others have hour glass shaped lenses to reduce tube contact and allow for flex.
